RARITAN RIVER BASIN  
CRAMERS CREEK, HUNTERDON COUNTY  
NEW JERSEY

NO NAME DAM NO. 31

NJ 00519

6 PHASE 1 INSPECTION REPORT  
NATIONAL DAM SAFETY PROGRAM.

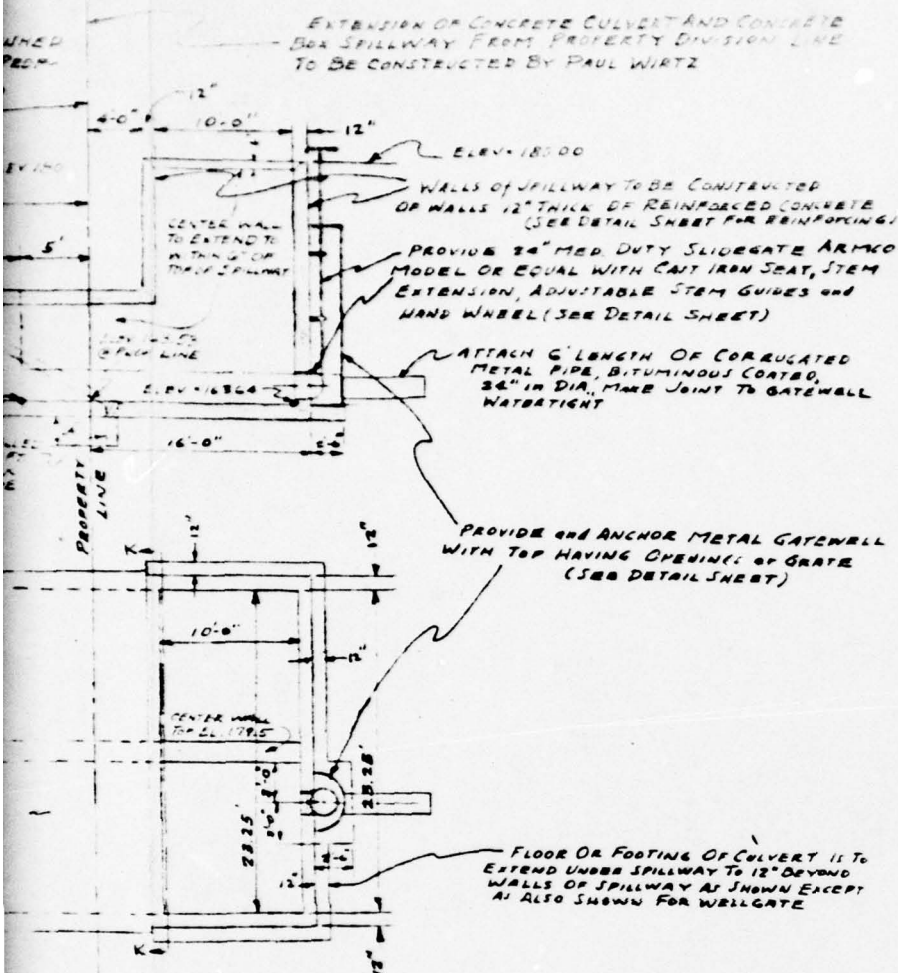
PLATE 3

PROPOSED CONCRETE CULVERT EXTENSION AND CONCRETE BOX SPILLWAY FROM PROPERTY DIVISION LINE IN NORTH-EASTERLY DIRECTION TO BE CONSTRUCTED AS SHOWN BY PAUL WIRTZ.
